REEVALUATION OF THE SEISMIC PERFORMANCE OF UPPER SAN FERNANDO DAM USING UNDRAINED SHEAR STRENGTH

Phu Huynh, Mark Schultz and Wallace Lam

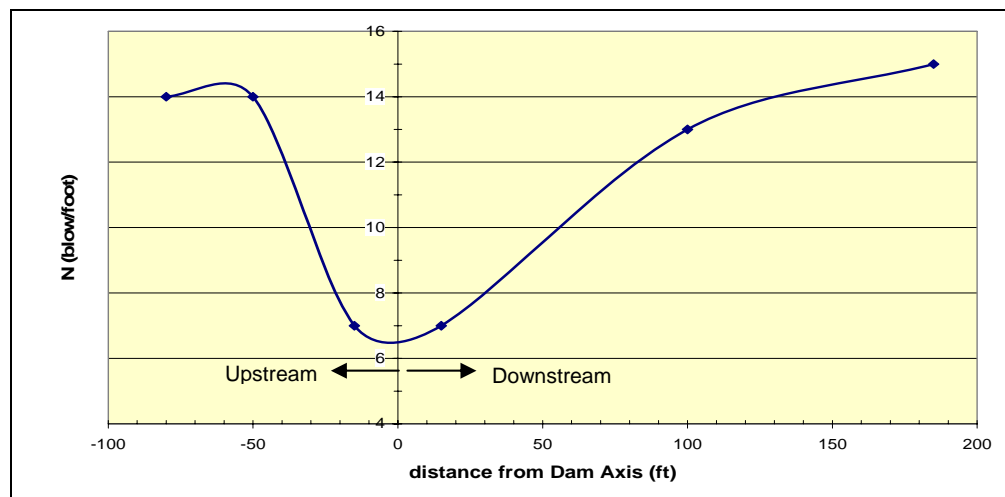
Figure 5: Average Blow Count Distribution

As previously discussed, the construction of the dam by “semi-hydraulic” procedure resulted in an embankment with coarser outer zones that transitioned to finer zones toward the center of the dam. The progressive change in soil characteristics were evidenced from the results of field and laboratory testing. The outer zones of the hydraulic fill were generally classified SW, SP, and SM, with dry densities in the range of 95 to 100 pcf. At the center of the embankment, the materials were designated as CL and CH, with dry density in the low 80’s pcf. Relative compaction, based on modified AASHTO, trended from about 93% in the outer zones to about 82% near the center. Similar trends were observed for SPTs, D50, dry density, and undrained shear strength as a function of distance from dam axis. Plots of these trends are shown in Figure 5 through Figure 7.

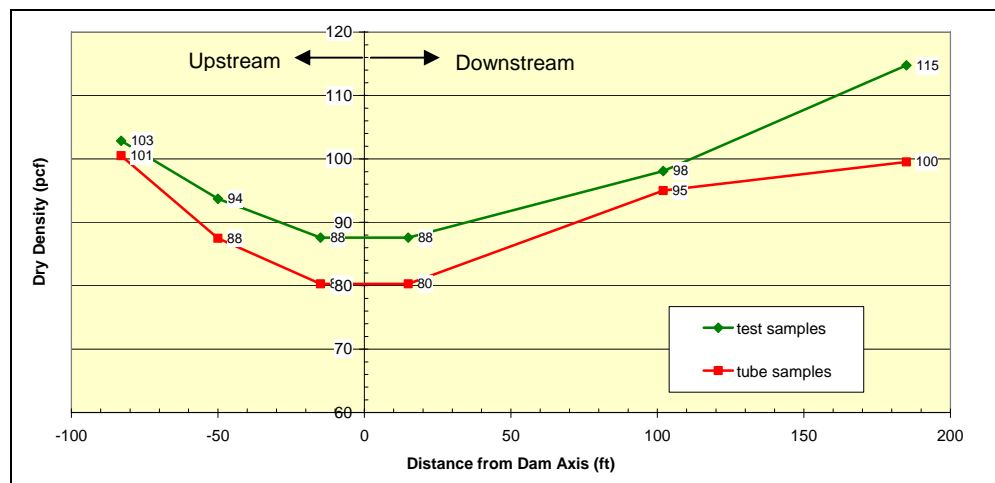
Figure 6: Average Dry Density Distribution

The geotechnical data revealed that soil samples used for the ICUE tests were densified during the consolidation process prior to shearing. The dry density, as measured in the sample tubes, was increased 3 to 15 pcf prior to shearing, as shown graphically in Figure 6. A proportional adjustment of the undrained shear strength was therefore made to reflect the shear strength for the in-situ density.

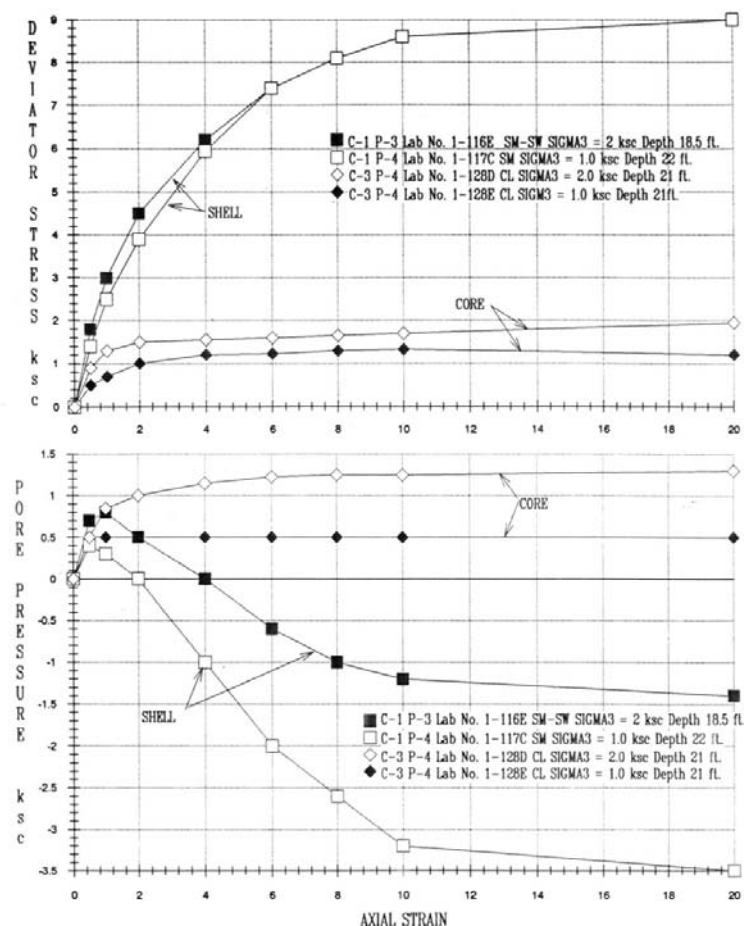
Figure 8: Typical ICUE Test Results for Hydraulic fill

Of the eighteen isotropically consolidated triaxial tests on the coarser-grained hydraulic fill materials, 67 percent of the tests showed dilative behavior at axial strain ranging from 2 to 10 percent. Typical plots of deviator stress and pore pressure versus axial strain are shown below in Figure 8.

The dilation of the coarser-grained materials indicates that these materials were generally dense. This behavior is contrasted by the pore pressure sustained at very large strains for the finer grained materials sampled from the center of the dam. As for the foundation alluvium, 82 percent of the eleven ICUE tests predicted dilation at axial strain from 2 to 8 percent.

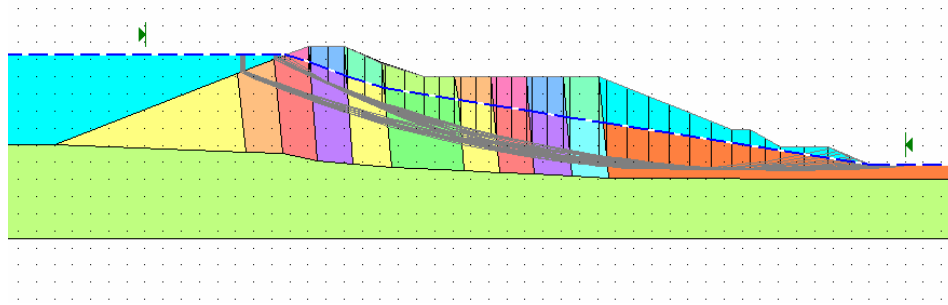
Figure 9: Limit Equilibrium Failure Surfaces

A slope stability analysis was conducted for a typical embankment cross section to determine failure circles based on limit equilibrium methods using the computer code SLOPE/W. An 11-zone 2D section was used, as described above. The location of the first 20 critical failure surfaces, with safety factors 1.00-1.03, is shown below in Figure 9. This band of potential failure surfaces coincides with the location and extension of the observed cracking along the upstream slope, and bulging at the downstream toe. The axial stress pattern of the outlet conduit pipe is consistent with this surface, and is discussed below. Yield accelerations were calculated for the potential upstream and downstream failure blocks using undrained shear strength at various levels of strain.

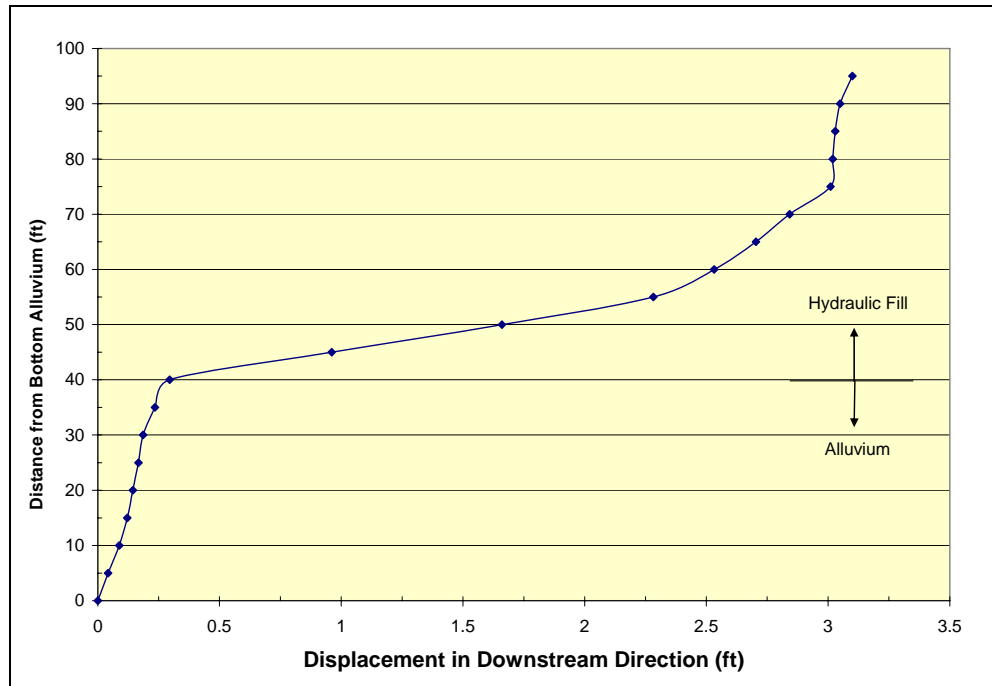
Figure 15: Horizontal Deformation Profile below Downstream Bench

Figure 15 and Figure 16 show the displacement and shear strain, respectively, along a soil column in the middle of the downstream bench. The shear zone in the embankment is about 30 feet thick at this location. It also clearly shows that the embankment portion above the shear zone moves as a block. The maximum percent strain from this location in the FLAC model is about 7%, which is similar to that calculated by the Yield Function Method.
